Nr.	Plant: Stoke	Month / Year: Feb-14	Dept / Who: STO-91	autoneum
Before		After

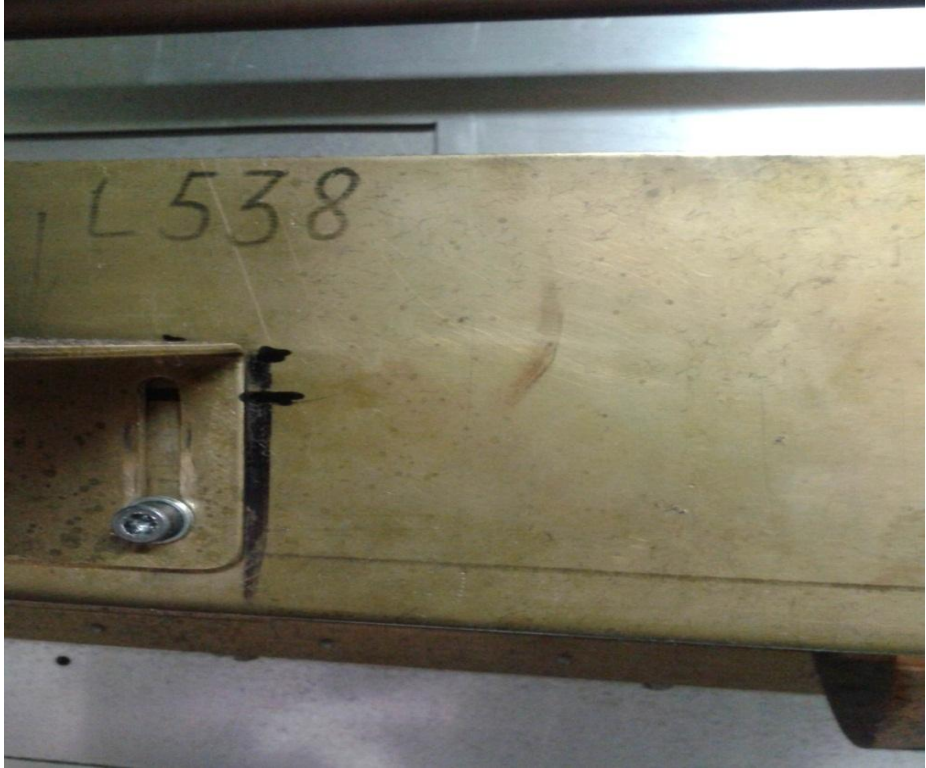
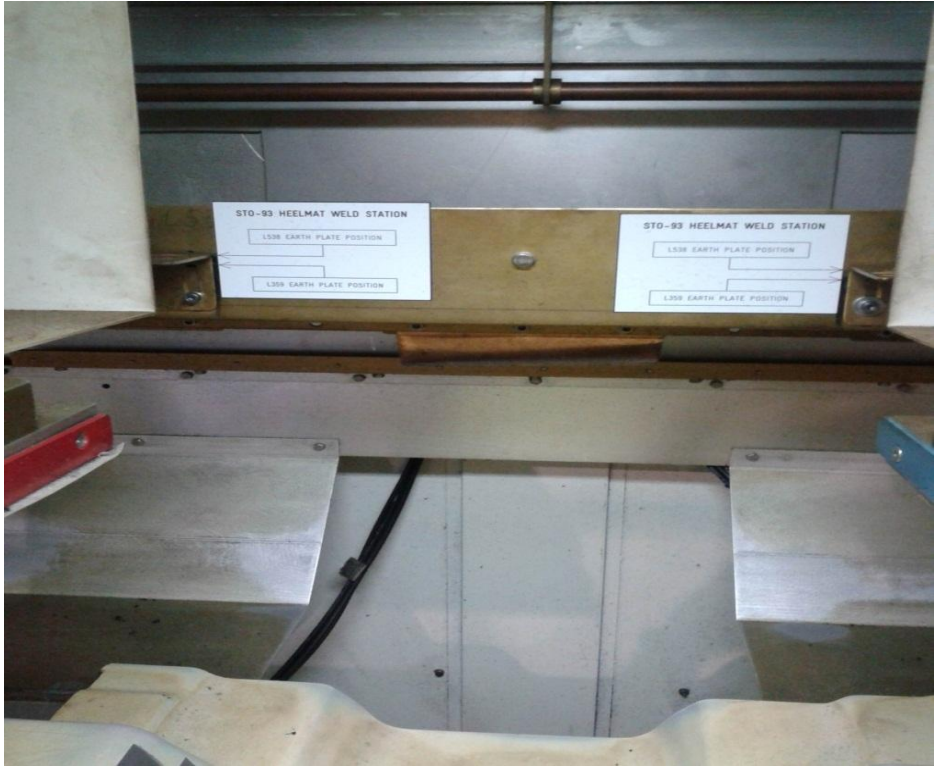
Problem observed	Root cause analysis	Taken action	Result	
<p>STO-93 Heelmat welder, Earth plate positions sometimes needs to be revisited following a product change due to weld fails.</p>	<p>STO-93 Heelmat welder, Earth plate positions identified with a dry marker pen, difficult to see and line up the position correctly.</p>	<p>Had x 2 plaques manufactures and fitted.</p>	<p>Heelmat set up positions are easily identifiable, eliminated the need to re-visit / re-align.</p>
